Tribological Studies of Modern Orthopaedic Biomaterial Combinations

Katelia Vassiliou, BSc

A thesis submitted for the degree of Doctor of Philosophy at the University of Durham

Centre for Biomedical Engineering

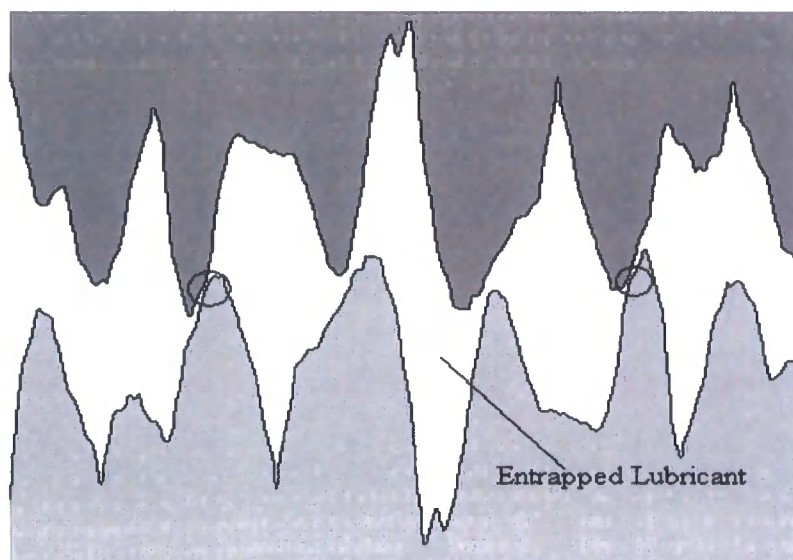
Figure 4. Surfaces in mixed lubrication condition; some of the load is carried by the entrapped lubricant while some is carried by the asperity contact of the surfaces.

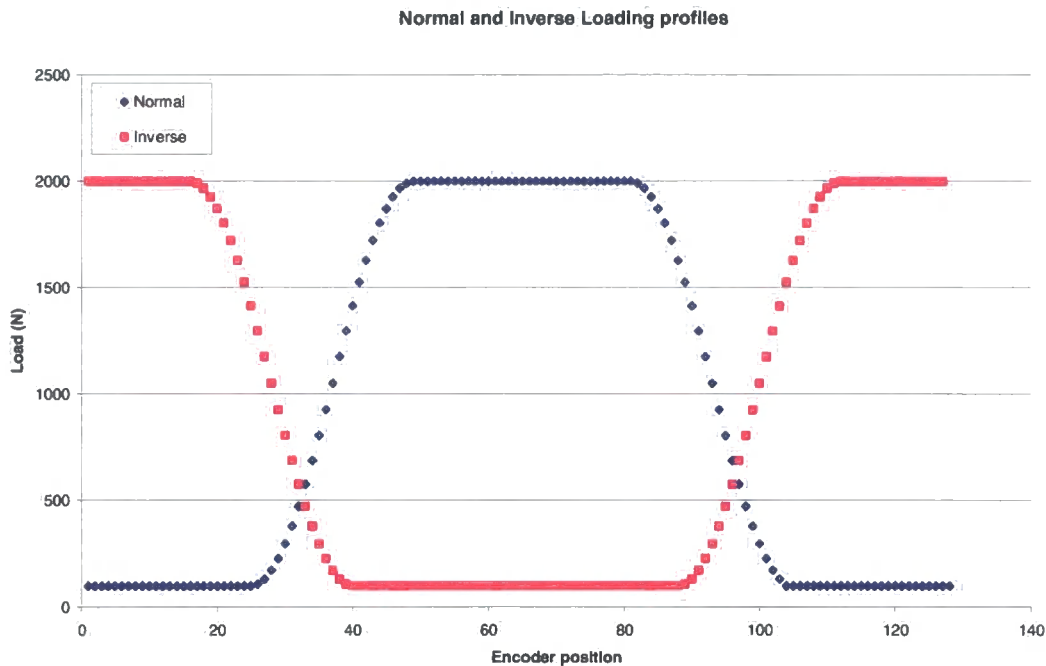
Figure 9. Applied loading profiles for the friction simulator

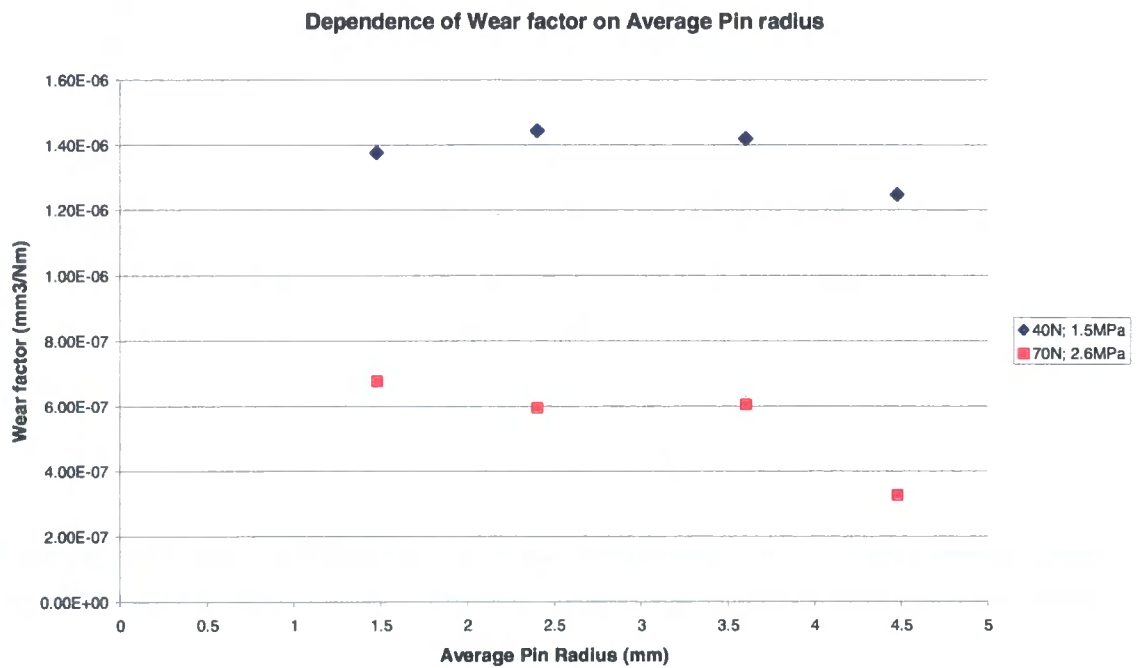
Figure 17. Dependence of wear factor on average pin radius for two conditions of constant stress: 1.5MPa and 2.6MPa.

Figure 17 shows the wear factors for the two tests carried out with pins of equal contact area. The wear for the 40N test was not affected by the outer radius of the pin ($R^2 = 0.353$). However, the 70N test does show some variation over the range of radii ($R^2 = 0.719$). Statistical analysis of the raw data for the 70N test showed that the wear factors on pins 1, 2 and 3 were not significantly different from one another, but all were significantly different from the wear factor on pin 4 (all $p < 1 \times 10^{-6}$). There is a slight drop in wear factor for the highest radius pin in the 40N test also, although this is not statistically significantly different from any of the wear factors on pins 1, 2 and 3.

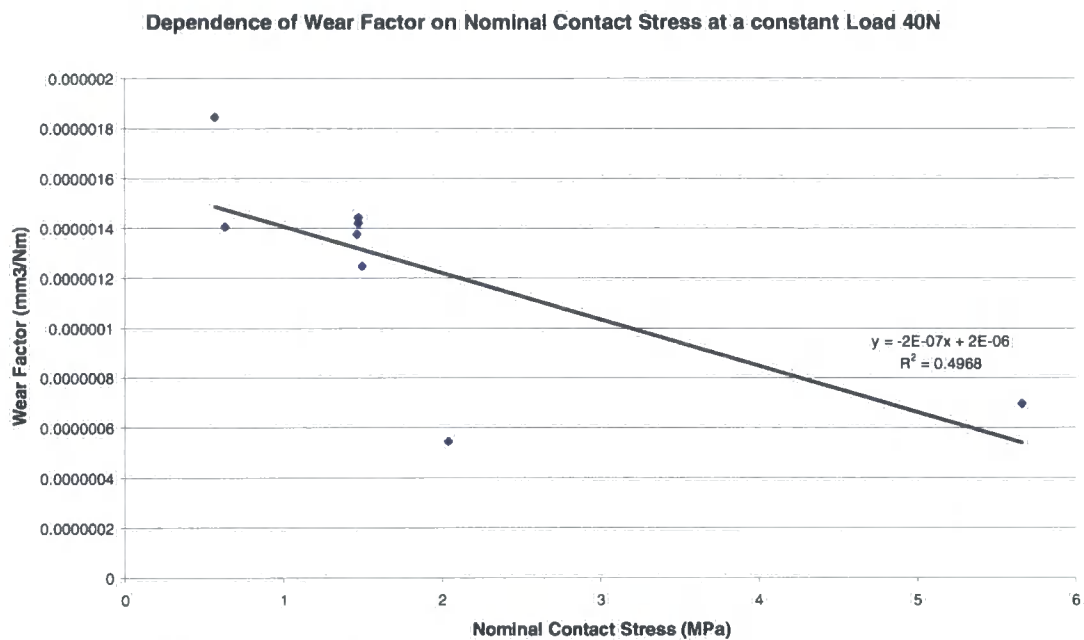
Figure 20. The dependence of Wear Factor on Nominal contact stress at a constant load of 40N.

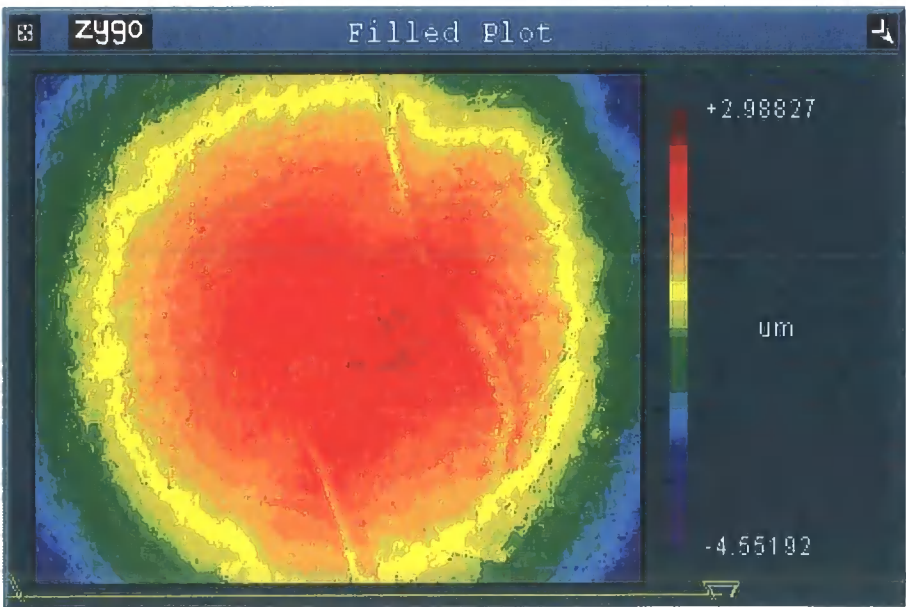
Figure 26. Central nipple on pin 1 of Test B, tested under 40N load and 1.46MPa stress

For all solid cross-section pins, a nipple became visible at the centre of the pin. This was slightly raised as can be seen in Figure 26 (area of view 181 x 136 μm). In addition some smaller features were seen on the micrographs both at the edges and towards the centre of the pin faces. A typical example is shown in Figure 27 (area of view 181 x 136 μm).

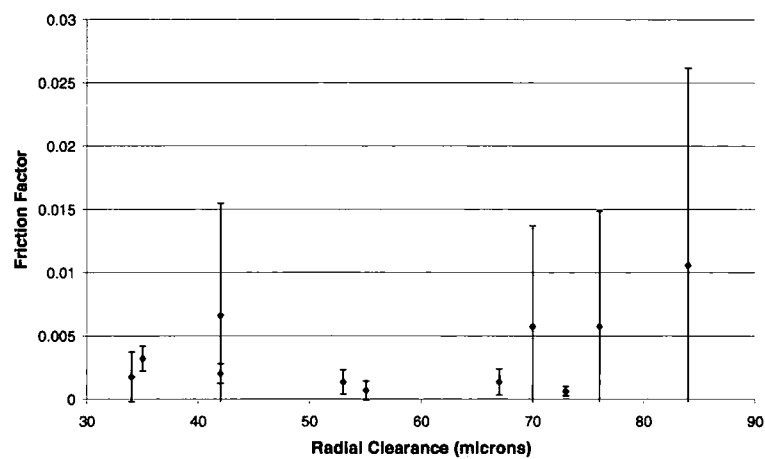
Figure 32. The effect of radial clearance on friction factor when tested with 0.1 Pa s CMC fluid

factor itself was lower than when bovine serum was used (0.03 for bovine serum, 0.01 for 0.1Pa s CMC in most cases). Even in the case of the 84µm clearance joint, which showed the highest friction factor, the value found with CMC fluid as a lubricant is lower than that with bovine serum lubricant. The increasing trend for high clearances is more evident with the 0.01Pa s lubricant as seen in Figure 33. The increase in friction factor was greater than for the more viscous lubricant, reaching 0.04.

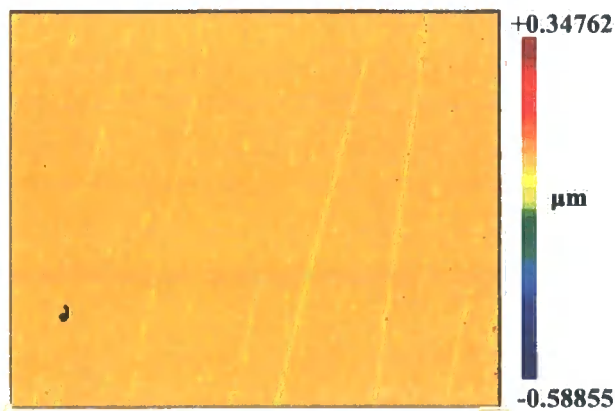
Figure 67. Surface profiles of cup 20 (non-roughened component) before testing(a), after friction testing (b), and after the wear test (c).
